Name Of Dam: LOWER NORTH RIVER NO. 80

Location: ROCKINGHAM COUNTY, STATE OF VIRGINIA

Inventory Number: VA 16501

PHASE I INSPECTION REPORT

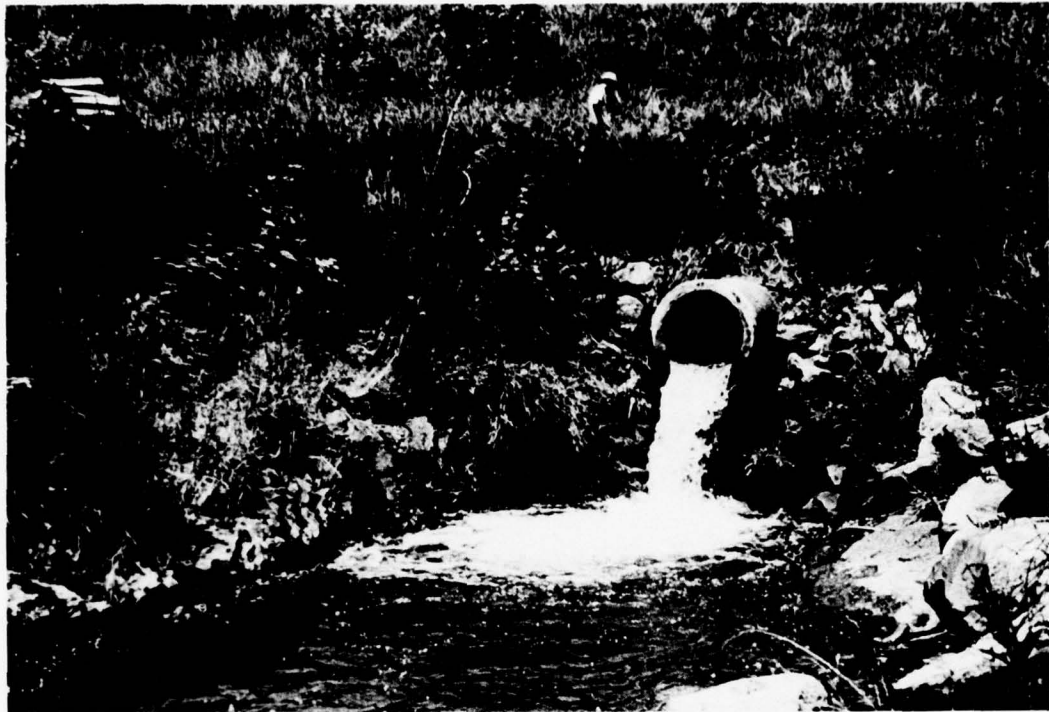
3.1.2 Dam: A small clear seep (person in Photo 1 is standing at location of clear seep) was noted on the downstream face of the dam at an elevation of 1526.5 located approximately ten feet to the right of the outlet pipe. Flow at the time of the visual inspection was estimated at less than one-half g.p.m. However, a six inch wide by two inch deep erosion channel, which indicates possible higher intermittent flows, had formed immediately below the origin of the clear seep. A fifteen feet by three feet marshy area is also present about one or two feet in elevation immediately down slope of this clear seep. This marshy area may be related to the above clear seep.

PHOTO 1. Principal Spillway Outlet - Stilling Basin

- 7.2.1 Clear Seep: Immediately, the owner should set up and maintain a regular observation schedule of inspecting the clear seep, during higher reservoir levels, to determine its source, prevent erosion and prevent a worsening condition from going unobserved. If as a result of these periodic inspections it is found that the flow is originating from the reservoir, then an in-depth investigation including a test boring program and piezometers is recommended. An inverted filter may be needed to prevent piping if the source of the clear seep is determined to be the reservoir.

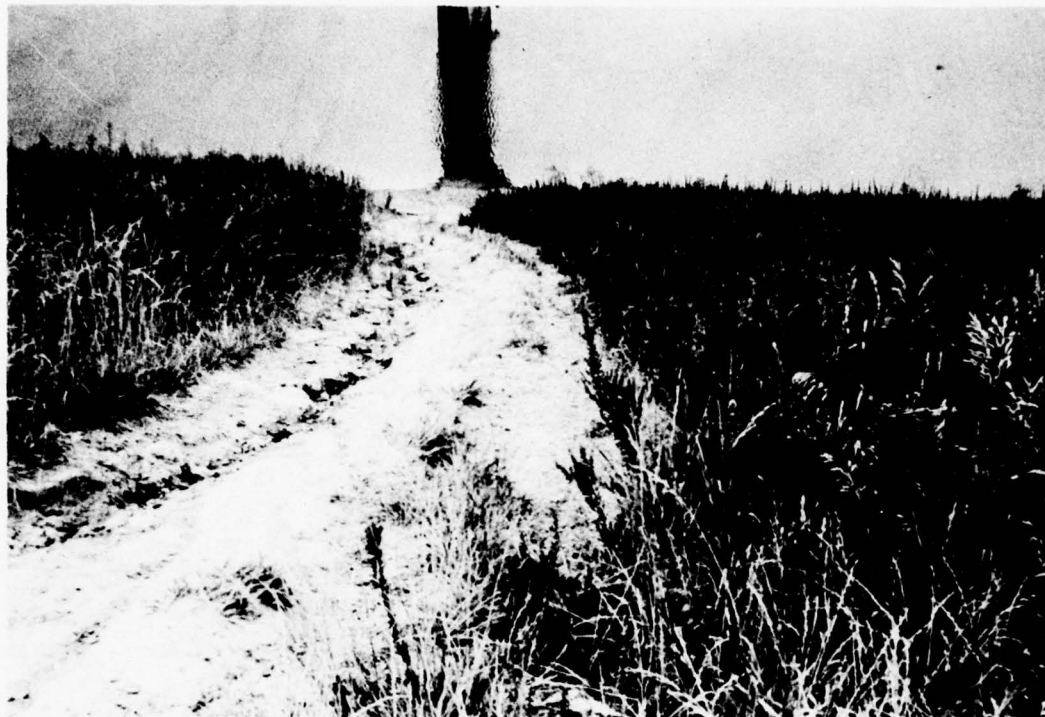
Minor erosion damage was observed during the visual inspection. A ten feet wide shallow eroded footpath was observed leading from the dam crest to the water edge down the center of the upstream side of the dam (see Photo 3 and Overall View of Dam). Minor erosion is also occurring along the downstream dam abutments due to runoff. Riprap had not been placed on the erosion control (wave dissipation) berm at normal pool level on the upstream embankment (see Photo 2). Consequently, this berm has eroded slightly due to water level fluctuations, wave action and pedestrian traffic.

PHOTO 3. Erosion on Footpath - Dam Crest to Water Edge

- 1) The small trees growing on the embankment should be removed.
- 2) The footpath on the upstream face of the dam should be repaired and reseeded, or a type of stairway should be constructed to prevent future damage.
- 3) The erosion channels along the downstream dam abutments should be filled and reseeded.

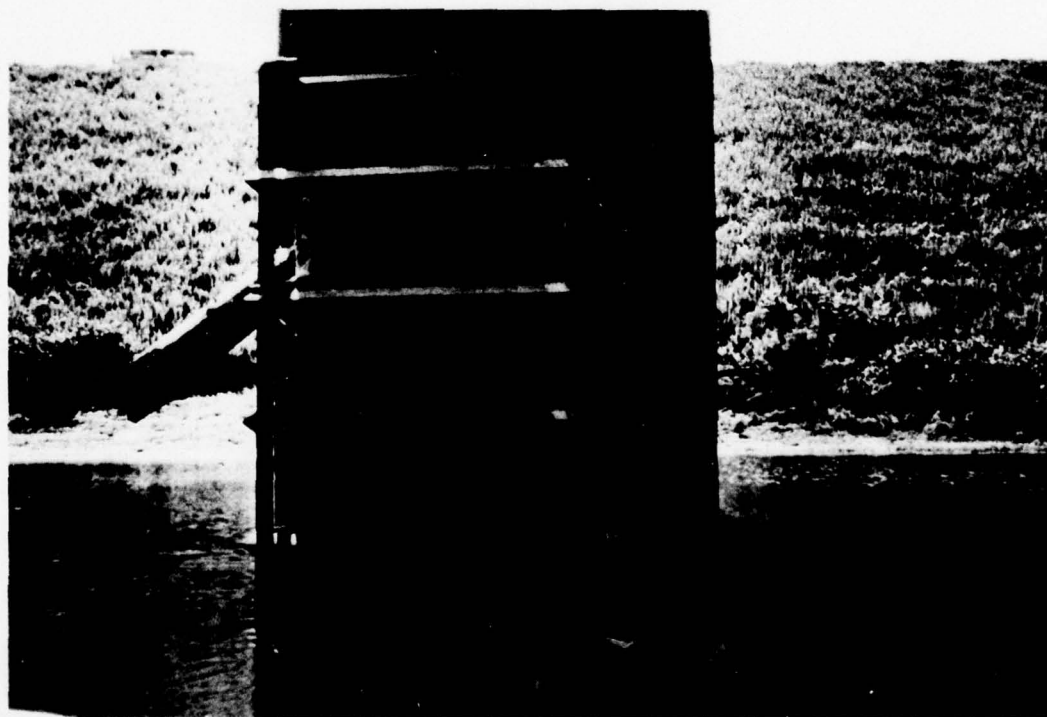
PHOTO 4. Debris in Low Stage Trash Rack

- 3.2.2 Appurtenant Structures: The trash rack should be inspected; and debris should be removed periodically from it, particularly during the heavy rainfall seasons. The upper handrail section on the riser access ladder should be replaced.
- 3.2.3 Reservoir Area: The reservoir area does not require further investigation.
- 3.2.4 Downstream Channel: The downstream channel does not require further investigation.
